**SUBJECT: EXPLORATORY TEST PIT REPORT – Jewett White Lead Company,  
Staten Island, Richmond County, New York**

## EXPLORATORY TEST PIT REPORT

**SITE NAME:** Jewett White Lead Company  
DCN #: RST2-02-F-0797  
TDD#: TO-0009-0126

**ACTIVITY DATES:** December 17 -18, 2008

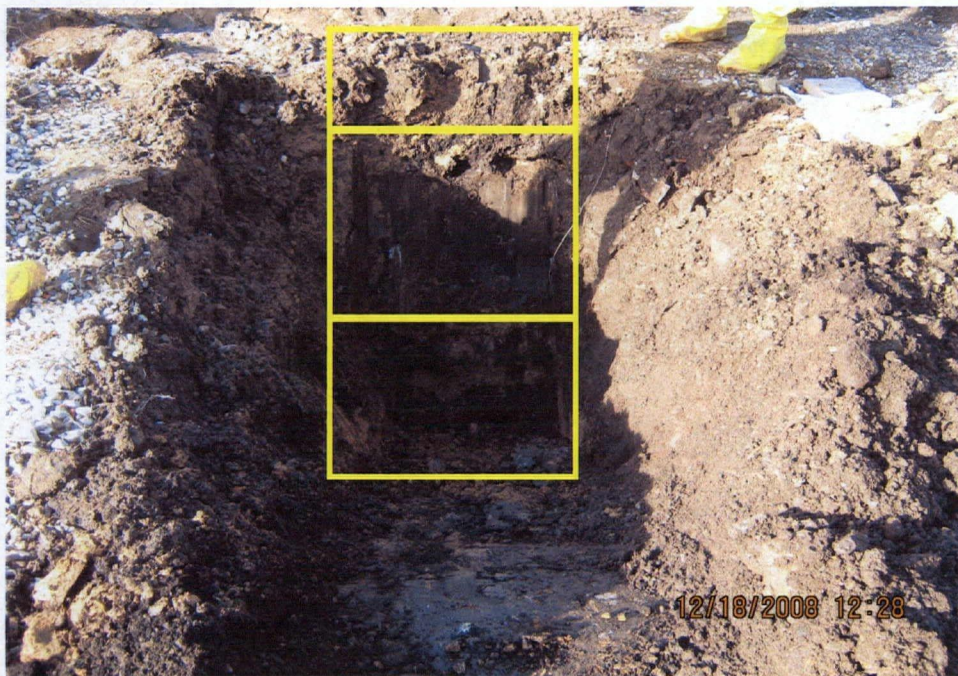
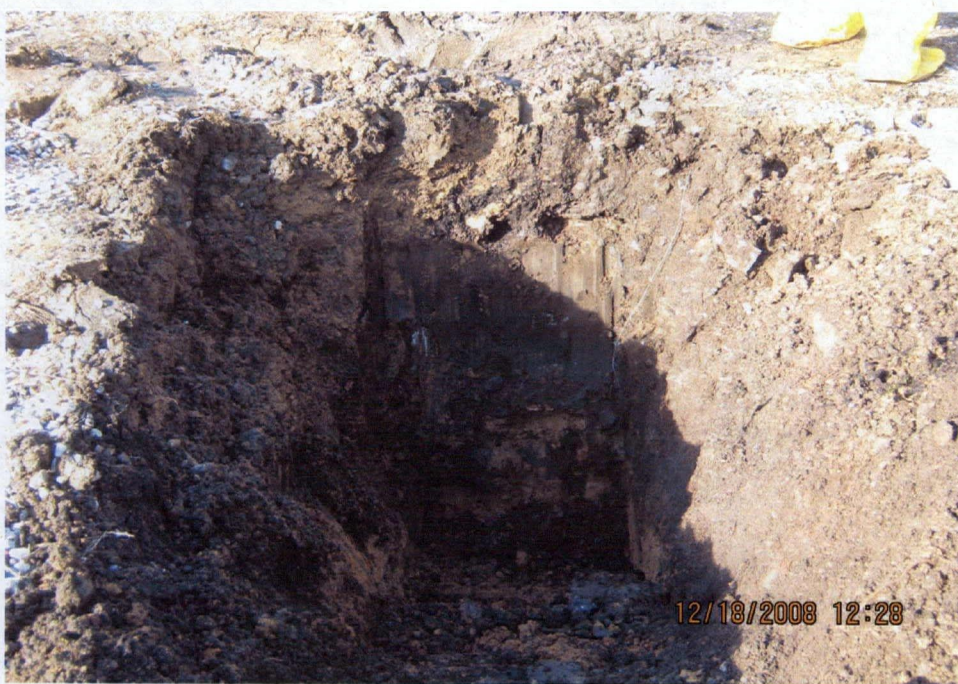
**Picture 31. Test Pit A-1**

0-6"	Brown clay with gravel
6"-32"	Black silty clay with brick and broken concrete
32"-48"	Light tan silty sandy clay with gray mottles

**Picture 32. Closer view of Test Pit A-1**

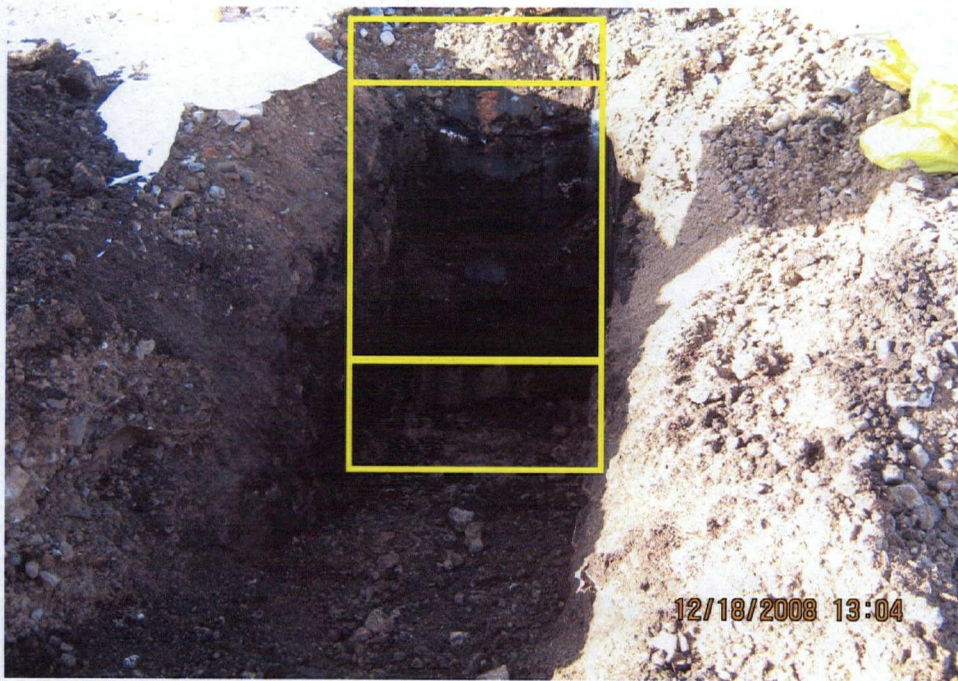
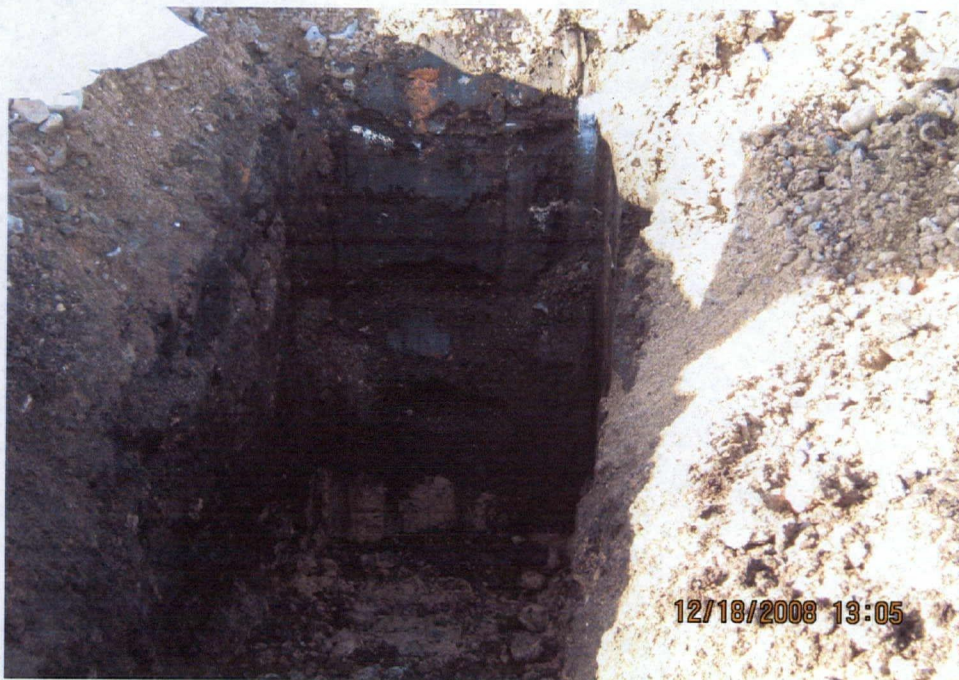
**Picture 33. Test Pit A-2**

0-4"	Gravel
4"-40"	Black clay, some brick
40"-48"	Light tan, sandy clay

**Picture 34. Closer view of Test Pit A-2**

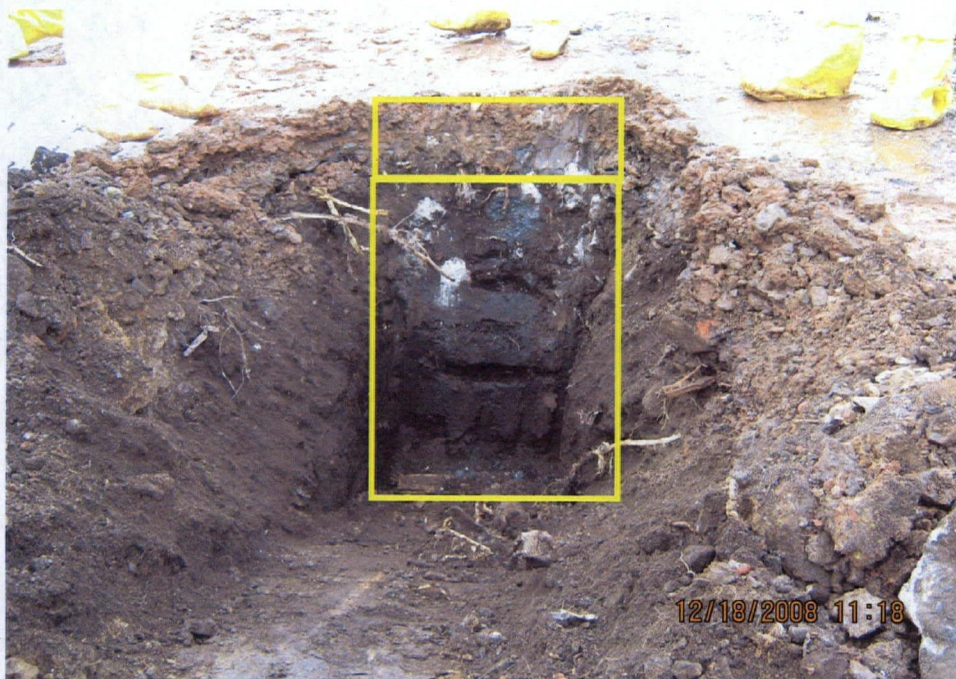
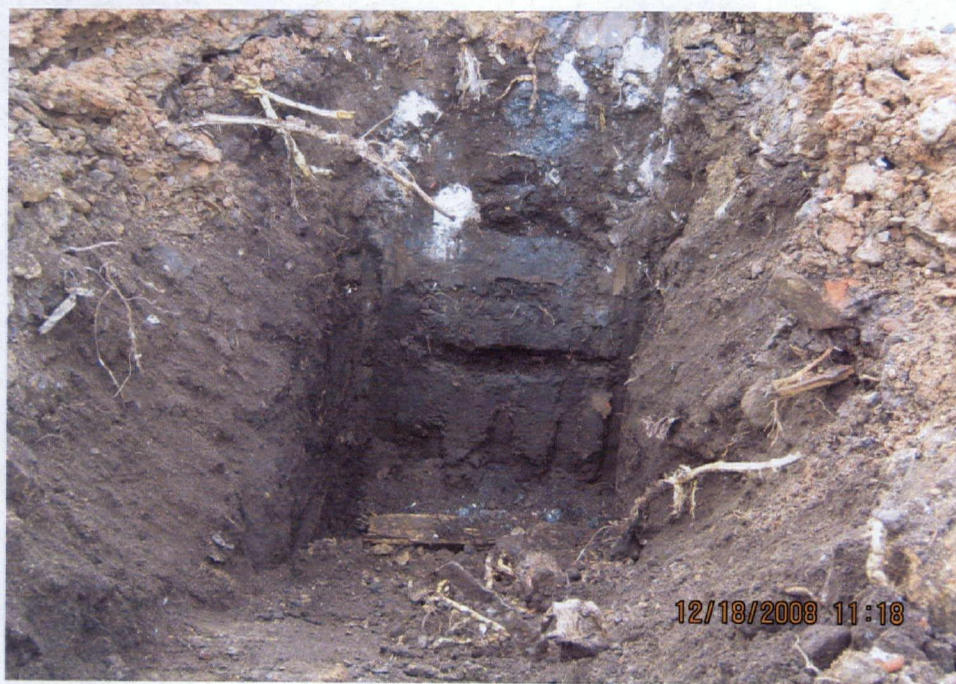
**Picture 27. Test Pit A-4**

0-10"	Brown muddy clay with gray gravel aggregate
10"-48"	Black loamy soil, roots and pieces of broken concrete

**Picture 28. Closer view of Test Pit A-4**

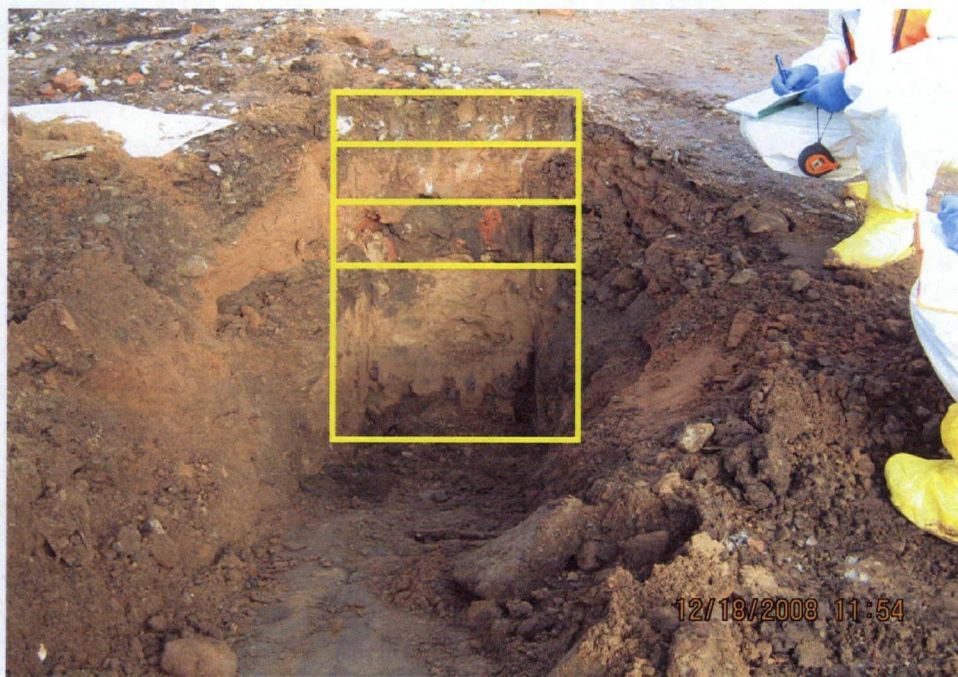
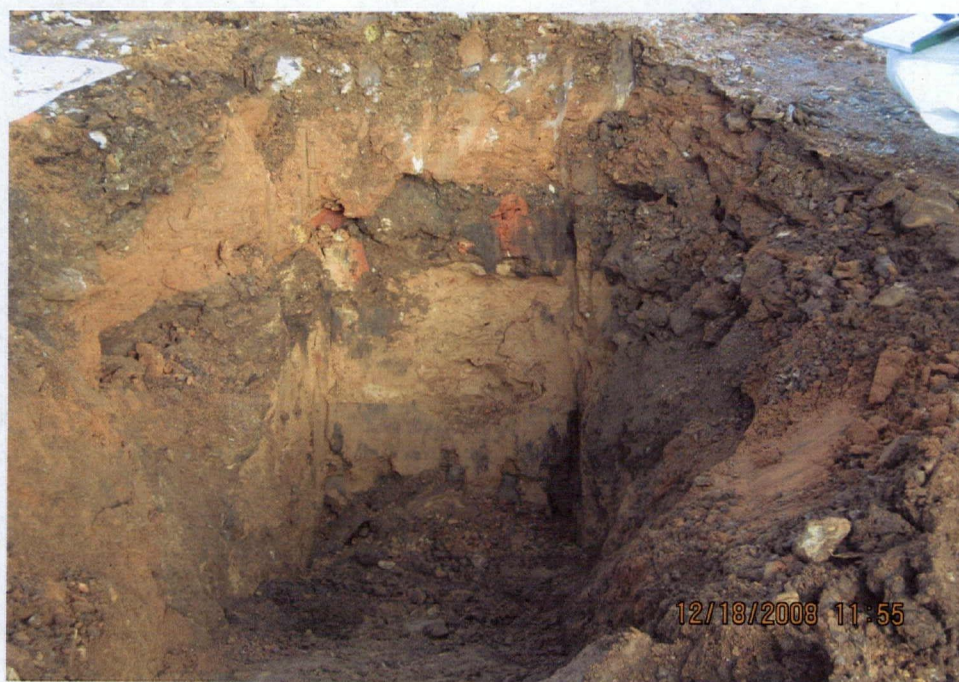
**Picture 29. Test Pit A-3**

0'-6"	Brown sandy clay with dark gray gravel and some brick
6"-16"	Reddish brown/tan sandy clay with some broken concrete
16"-27"	Dark brown/black sandy clay with much gravel (gray gravel)
27"-48"	Light tan sandy silty clay with some gray areas

**Picture 30. Closer view of Test Pit A-3**
